May 13, 2024  
ES-9388.01

**Subject: Groundwater Level Monitoring Summary**  
**927 Alder Avenue**  
**Marysville, Washington**

As requested, Earth Solutions NW, LLC (ESNW) has prepared this letter summarizing the results of seasonal groundwater level monitoring on the subject site.

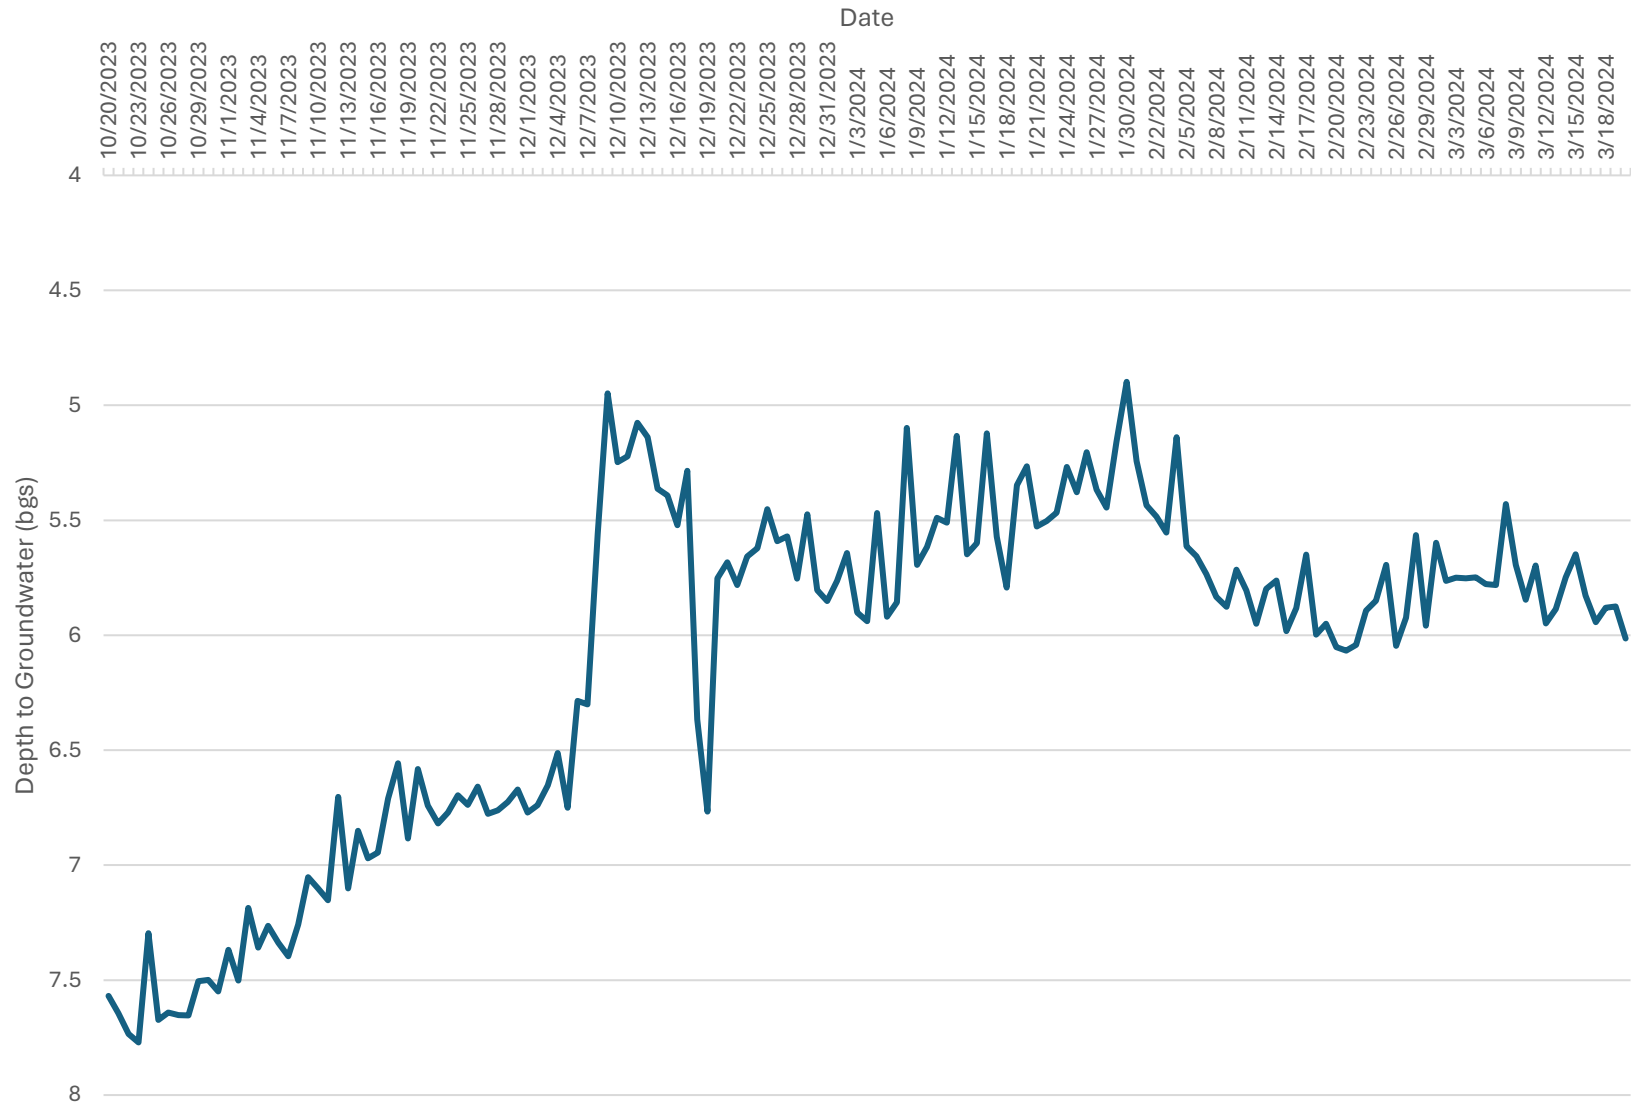
# TP-3 Groundwater Level

| Test Pit | Depth of Test Pit (ft.) | Ground Elevation* (ft.) | Peak GW Depth† (ft.) | Peak GW Elevation* (ft.) | Peak Date |
|---|---|---|---|---|---|
| TP-3 | 10 | 34 | 4.9 | 29.1 | 1/30/2024 |

Groundwater level monitoring charts are attached to this letter, along with the relevant test pit logs and laboratory analyses from the October 2023 fieldwork. Based on the data collected during the monitoring period, it is our opinion the peak groundwater depths listed in the table above are indicative of the seasonal high groundwater levels.
